**Titu Maiorescu University**

# DOCTORAL THESIS (SUMMARY)

## INNOVATIVE ASPECTS REGARDING IMPLANTS USED IN ORTHOPEDIC CONDITIONS FROM THE PERSPECTIVE OF BIOMATERIALS

**PhD Candidate: CORDUNIANU MIHAI ALEXANDRU**

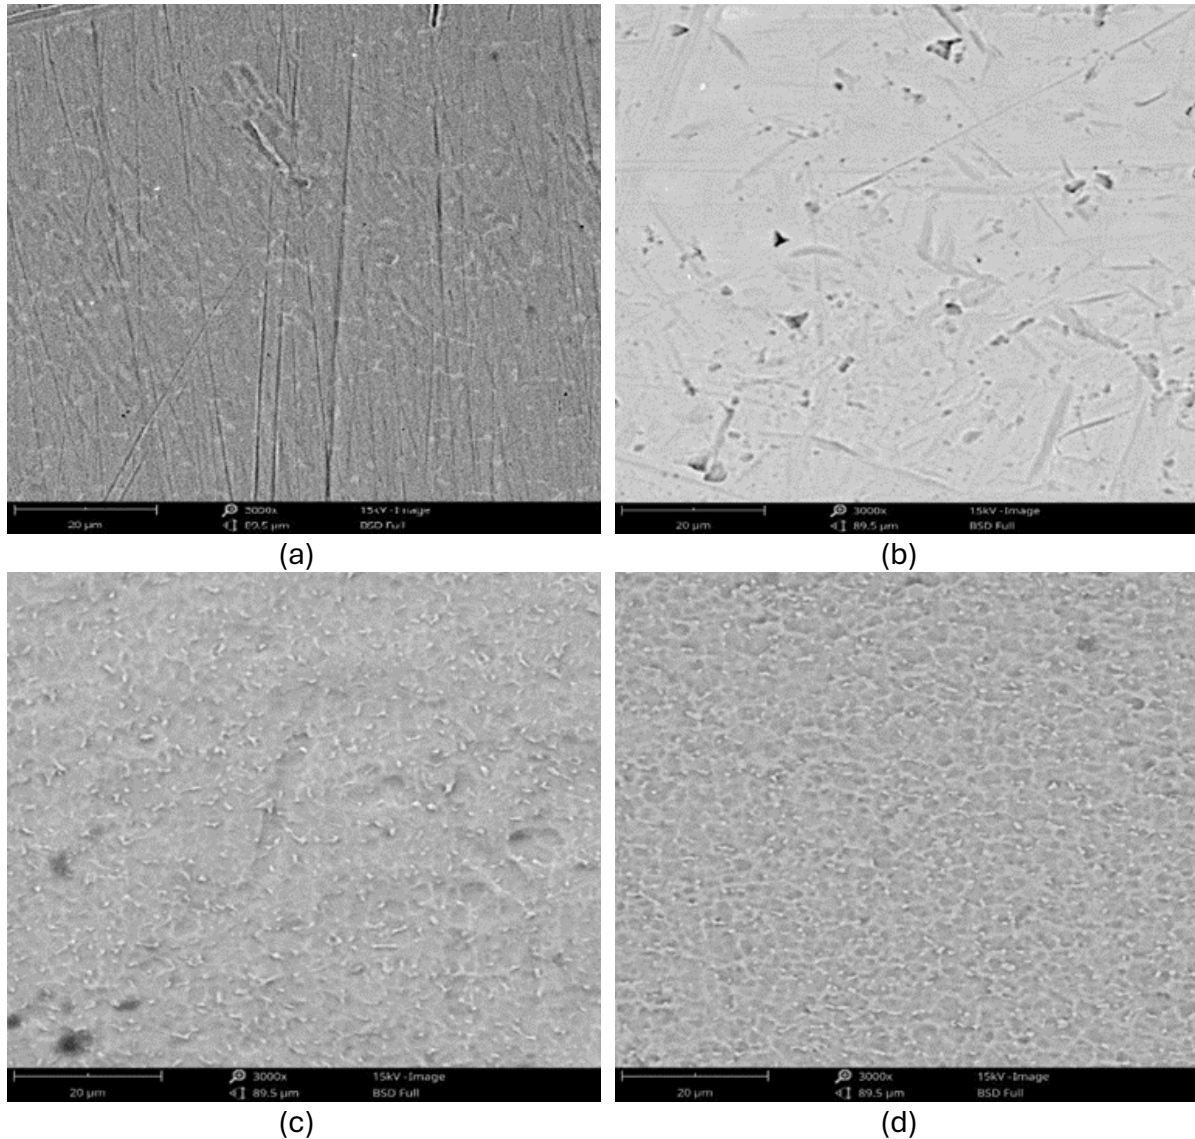
For the gray screw (with a layer thickness of up to 25 μm), shown in Fig. n.a, deep and shallow grooves oriented in the same direction can be observed, likely resulting from a surface preparation step before anodization.

As the layer thickness increases, fewer surface defects are visible (Fig. n.b for the blue screw, with a layer thickness between 25-50 μm), and at greater thicknesses (violet, 75-100 μm, Fig. n.c, and green, 100-125 μm, Fig. n.d), the surface topography is dominated by the specific structure of the anodized layer, formed by groups of nanotubes.

**Figure 4.5.** The microstructure of the analyzed titanium alloy samples observed through scanning electron microscopy: a - gray anodized screw, b – blue anodized screw, c – violet anodized screw, d – green anodized screw

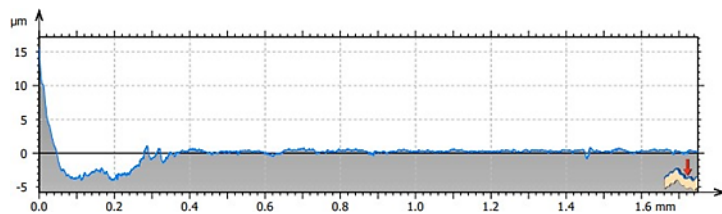
*Probe 1 - gray anodized screw*

| Rq | 0.9846 μm |
| Rsk | -2.6010 |
| Ra | 0.6044 μm |

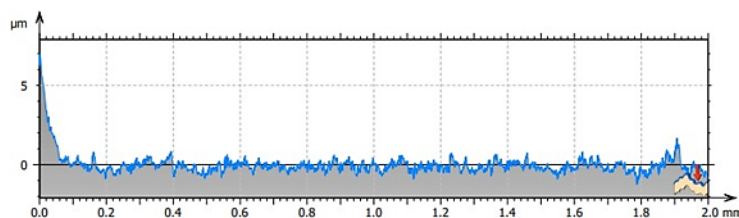
*Probe 2 - blue anodized screw*

| Rq | 0.6937 μm |
| Rsk | 5.3437 |

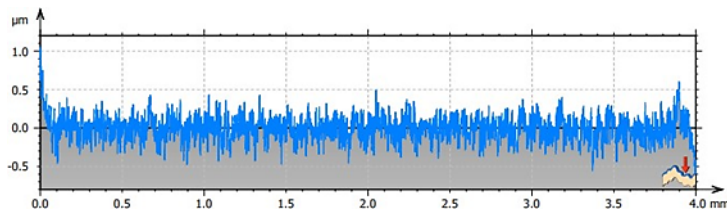
| Rz | 0.8508 µm |
| Ra | 0.1206 µm |

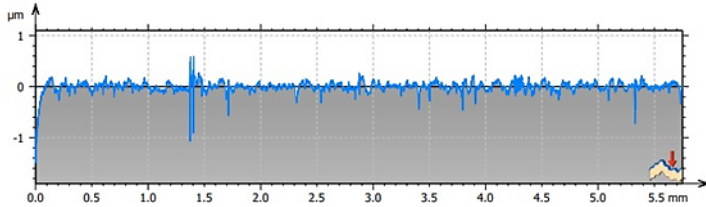
*Probe 4 - green anodized screw*

| Rq | 0.1134 µm |
| Rsk | -3.8592 |

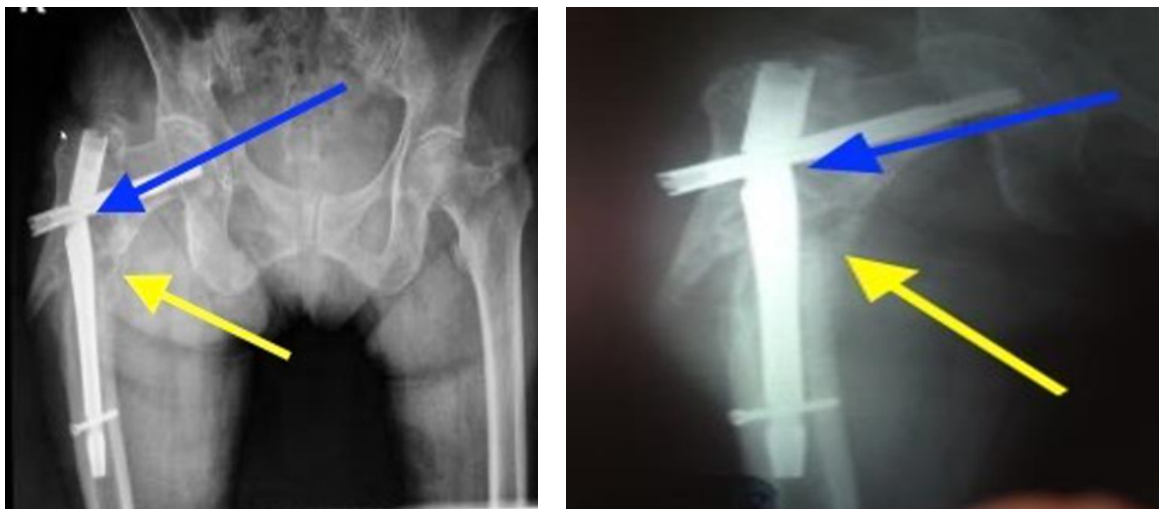
Six months after the intervention, the patient experienced pain and reduced mobility in the right hip. These symptoms are attributed to the lack of fracture consolidation, which may compromise the implant's integrity. These issues are illustrated in the presented X-ray (Figure 5.6).

**Figure 5.6** Radiographic images showing the implant deterioration (blue arrow) and the absence of bone healing (yellow arrow)

Following the radiographic evaluation, it was decided to remove the implant and replace it with a dynamic condylar screw (DCS) system. After the Gamma nail was removed, it underwent experimental analyses to determine the causes of its functional failure.

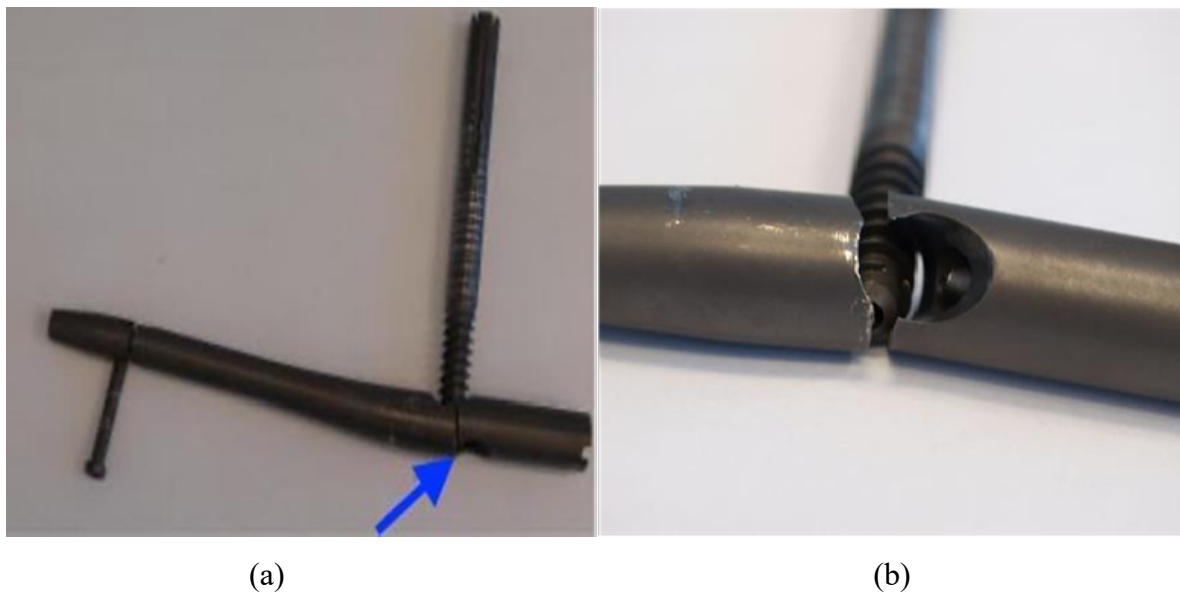
Figure 5.7 illustrates, at a macroscopic level, the implant after extraction, providing an overall view of its condition. The failure point is highlighted by the blue arrow. The causes of the failure may be attributed to the presence of cracks, structural deformations, or corrosion.

**Figure 5.7** The removed implant. The blue arrow indicates the point of failure. (a) Macroscopical examination after implant removal. (b) Highlighting of the failure point

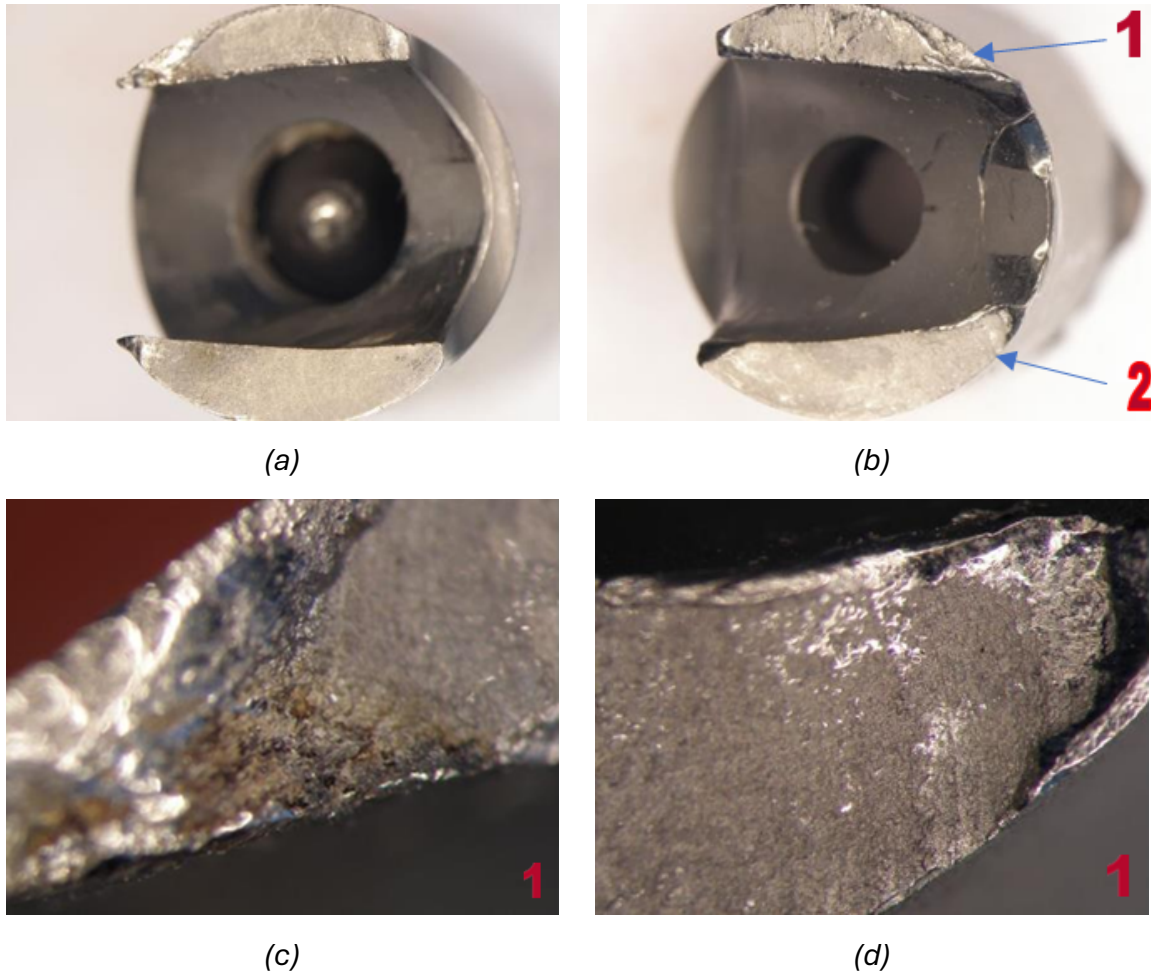
**Figure 5.8.** Stereomicroscopic images of the failure area

Following the stereomicroscopic analysis of the implant's failure surface, the characteristics of the fracture zones can be observed, as illustrated in Figure 5.8. The component exhibits a low and constant energy fracture, highlighted by the presence of propagation lines, followed by a sudden final rupture. The intergranular fracture has a matte appearance and tends to form three distinct zones: the initial zone, the propagation zone, and the sudden, final rupture zone, which occurred over a short period of time (Figure 5.8-a).

In Figure 5.8-b, the fatigue fracture is emphasized, which also occurred over a short period. The failure shows a combination of fracture types, both ductile (1) and brittle (2). In Figure 5.8-c, an intergranular fracture covered by a thin layer of oxides can be observed. The details of the area reveal a cup-and-cone fracture type (Figure 5.8-d).

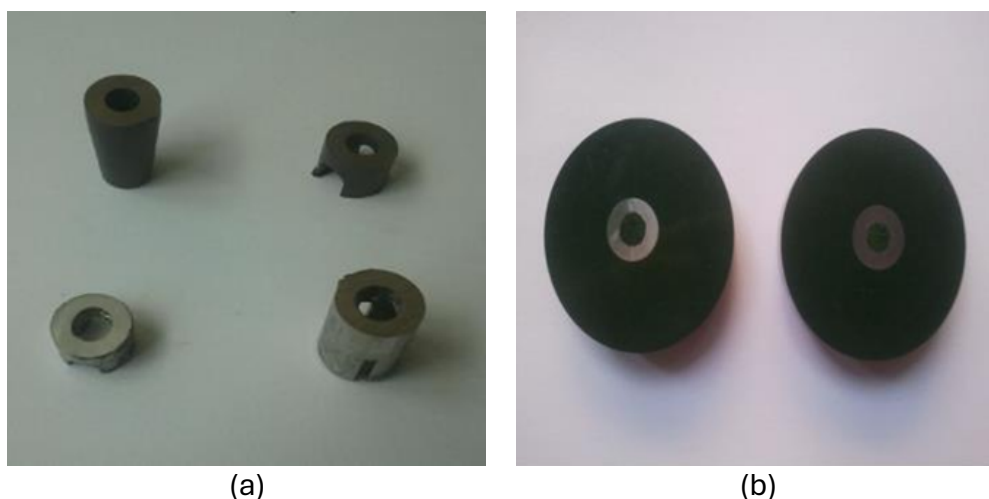
**Figure 5.12.** Samples before processing (a). Samples after cutting, embedding, grinding, polishing, and chemical etching (b).

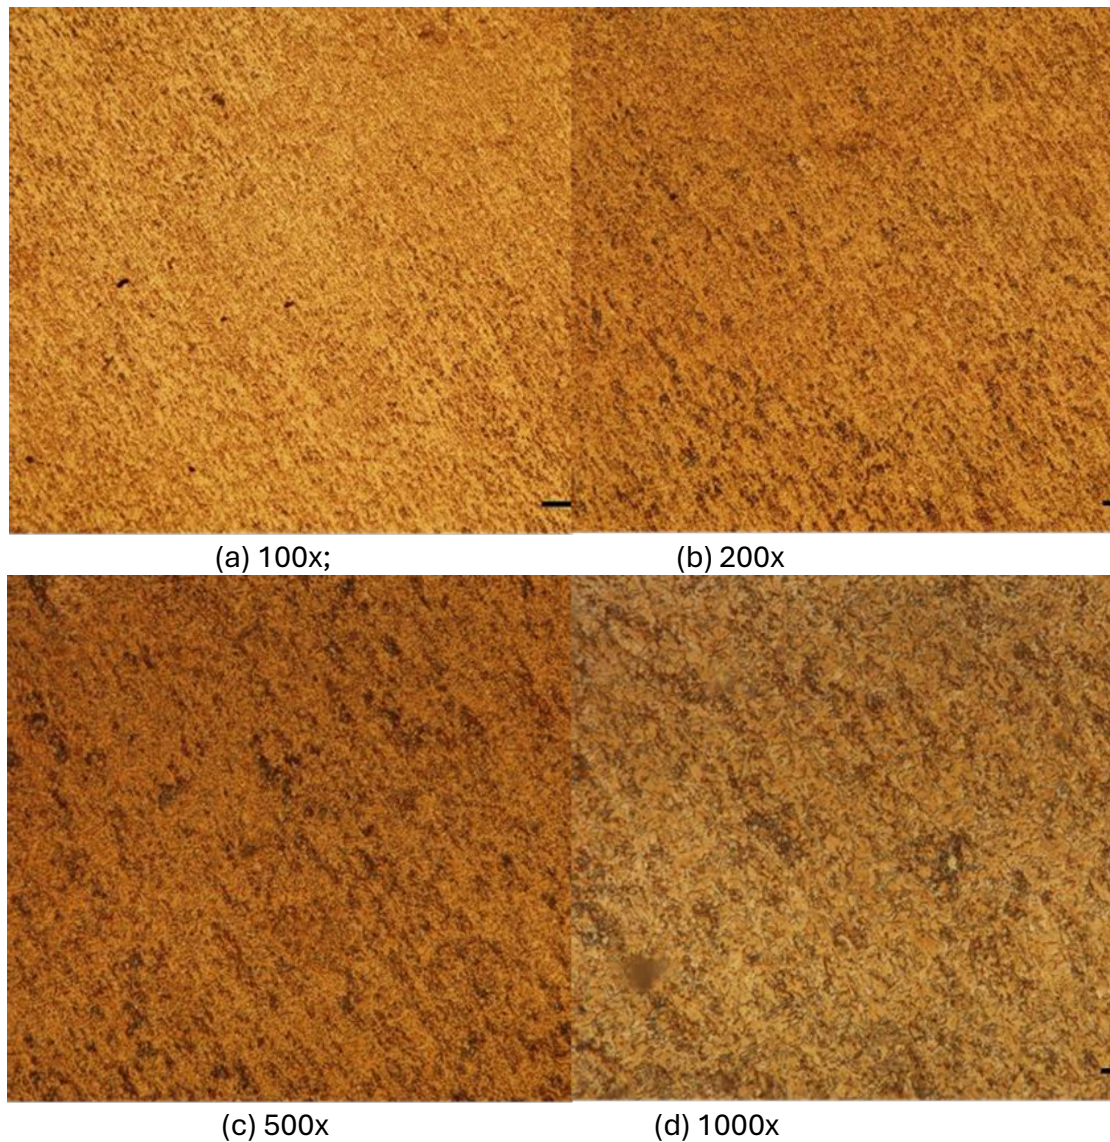
The images obtained using the optical microscope, shown in Figure 5.13, reveal a classic biphasic α+β structure, most likely resulting from a quenching heat treatment. The elongated shape of the grains is attributable to the plastic deformation processes that the material underwent (Figure 5.13.a-d).

**Figure 5.13.** Optical microscopy images at different magnifications related to the microstructural characteristics of the implant, specifically the Ti6Al4V alloy.

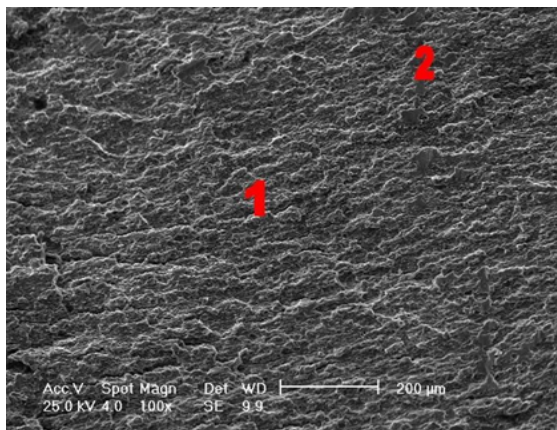
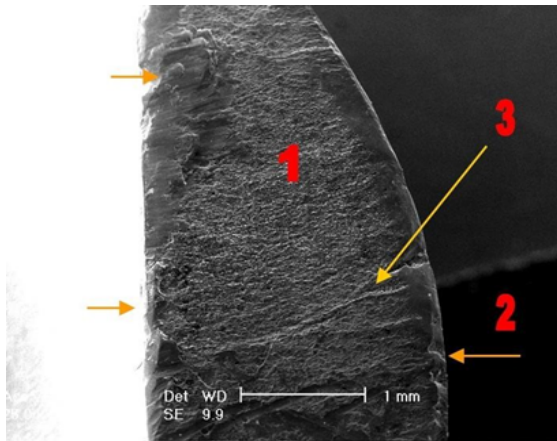
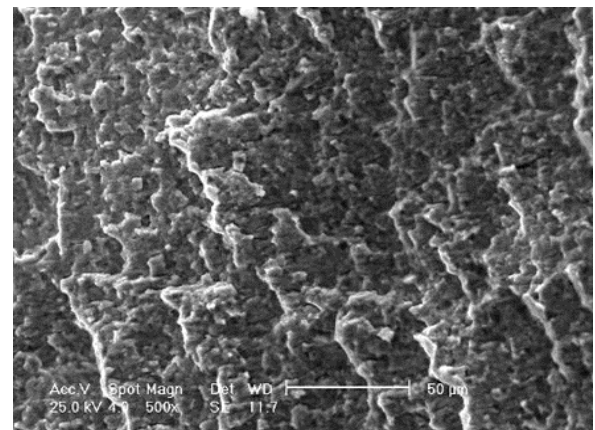
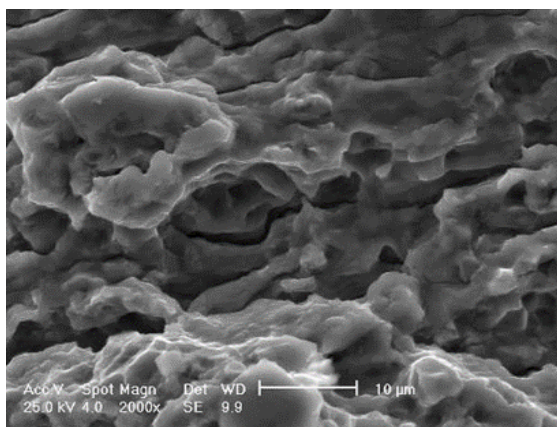
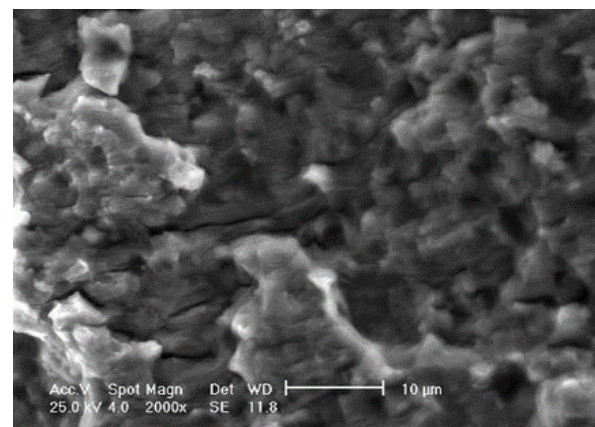
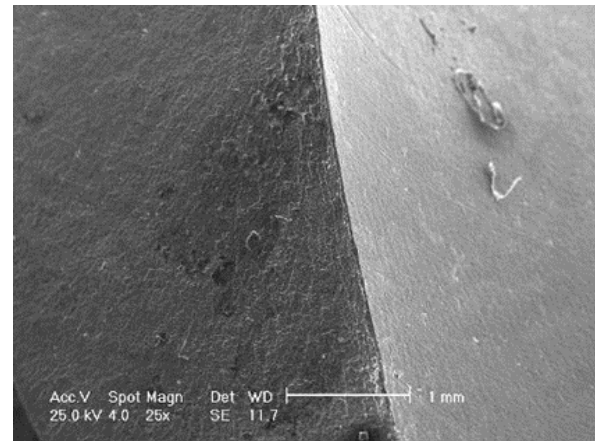
**Figure 5.14** Electronic microscope images of the failure areas

In Figure 5.14-a, the intergranular fracture zone with a matte appearance, covered by a thin oxide layer (1), can be observed, highlighting the cup-and-cone characteristics of the fracture (2), as well as its propagation lines (3). In image b, intergranular fracture zones with small voids and oxides are visible on the coated sample's surface. The mixed fracture nature, at a magnification of 100x, is noticeable through the presence of brittle (1) and ductile (2) fracture zones in image c. Image 5.15-d shows a fracture magnified 500x, revealing relatively uniform dimples (approximately 10 μm) of ductile fracture, as well as relatively parallel fracture zones. Image 5.15-e highlights ductile fracture characterized by the presence of cup-and-cone

features. In image 5.15-f, the fracture zone at 2000x magnification shows relatively uniform dimples (ductile fracture) and the propagation of cracks both parallel and into the depth of the sample (Figure 5.14.a-f).

The scanning electron microscopy analyses did not reveal structural inhomogeneities in the fracture zone.

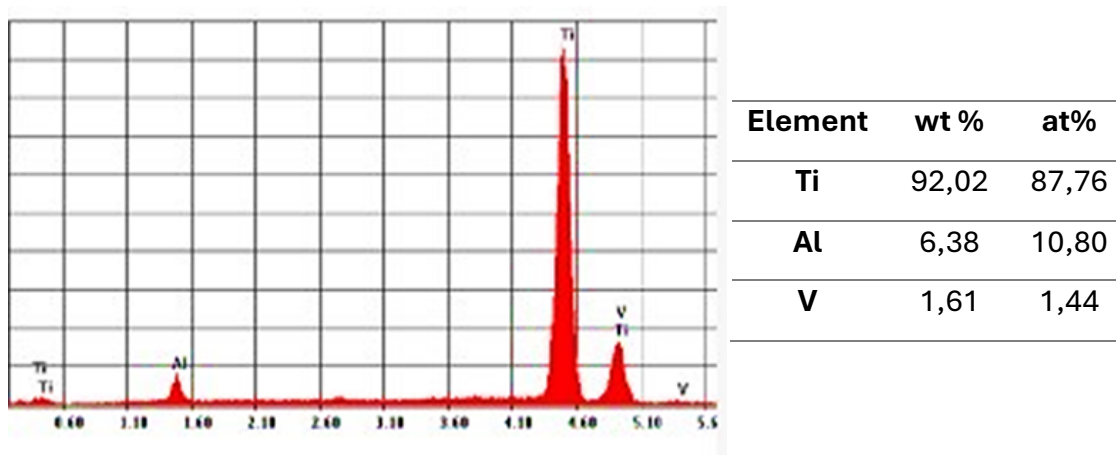
Following the quantitative and qualitative analysis performed on the failed material, along with the analysis of the X-ray emission spectrum, an evaluation of the Gamma rod's composition was conducted. It was found that the material primarily consists of titanium, aluminum, and vanadium, characteristic of Ti6Al4V titanium alloys, as shown in Figure 5.15.

**Figure 5.15.** EDS spectrum and compositional analysis results of the Gamma nail

- Experimental analyses using microscopic techniques validated the conformity of Gamma nails regarding their chemical composition and microstructure, highlighting that implant failure was caused by surgical technique errors. Subjected to mechanical overload, the intramedullary nail failed, displaying ductile-type fracture characteristics.
